Baker & Provan Engineering News

April 2007 Newsletter

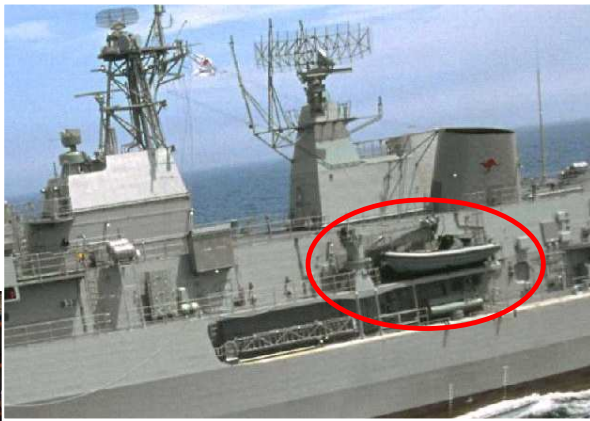
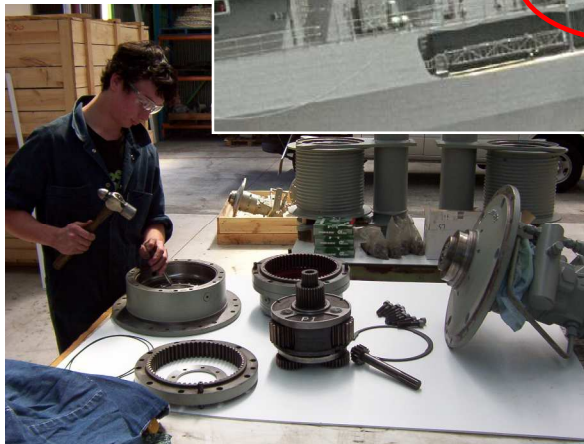
With the amount of servicing, repair and general assembly requirements that Baker & Provan performs, Baker & Provan has recently invested in creating a cleaner fitting environment away from the general workshop. While the fit out of the dedicated fitting bay is underway, it is expected to be completed in the next few weeks. The pictures above show HMAS Anzac crane and one of our apprentice fitter/machinists John Mason-Trinnie "carefully" disassembling parts on the HMAS Parramatta Cranes (ANZAC Class) in our dedicated fitting bay - still under development.

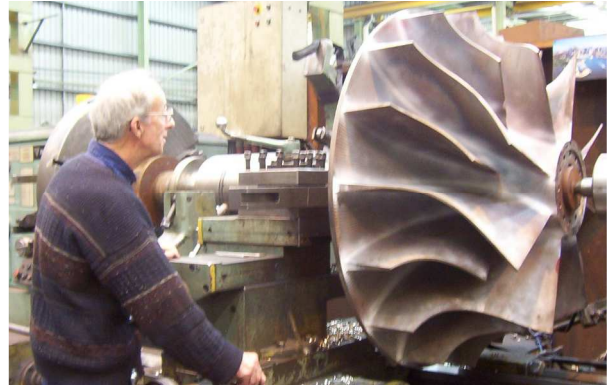
Baker & Provan's 12 metre lathe comes in handy for all sorts of interesting jobs and the job in the picture above right with the large impeller is no exception. This impeller is a ventilation fan for a mine in Western Australia. What makes this job interesting is that the impeller's operational speed is approximately 4,000 rpm. Now while that isn't as fast as other blowers and impellers, it is quite fast when noting the OD is around 1.4 metres in diameter. Also, as these impellers have very high stresses on them, to achieve the strength requirements they are milled from a solid block of alloy steel (by the OEM out of Europe).

Baker & Provan's role was to carefully separate the shaft from the keyway which was seized onto the impeller. The shaft was first turned down on the lathe by Peter McDonald (pictured) to be cut off. Then the seized section was milled out very carefully, removing minimal material from the impeller's internal diameter. The impeller was then TIG welded and re-machined. During this entire process, our customer had their Quality Inspector, who'd flown in from Europe to oversee the repair procedure. As any shortfalls in the workmanship would be quickly found out when rotating at 4,000 rpm, hence the customer's close inspection.

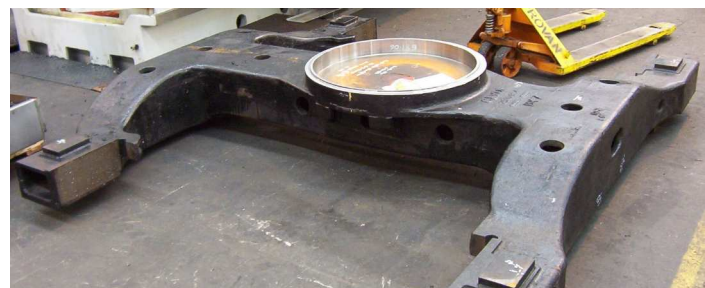
The bogie below had the liner bush on the centre pivot point wear through to the housing. The customer suggested welding as the repair procedure. However, an alternative repair procedure was required for this bogie where it was a single casting. Metal spray was considered as an alternative method of repair, albeit briefly. Baker & Provan suggested that an insert be locked into position without any welding and machined back to specification. This method of repair maintains the capability of the bogie and avoids any heat being applied into the aged material, providing the best possible technical solution at a competitive price.

This process was accepted by the customer and the repair was successfully completed, with the customer satisfied with the new repair process.
