# Baker & Provan Engineering News

## January 2007 Newsletter

### ■ 30 Tonne, CNC Controlled, 6 Axis, Turn Table on Floor Borer

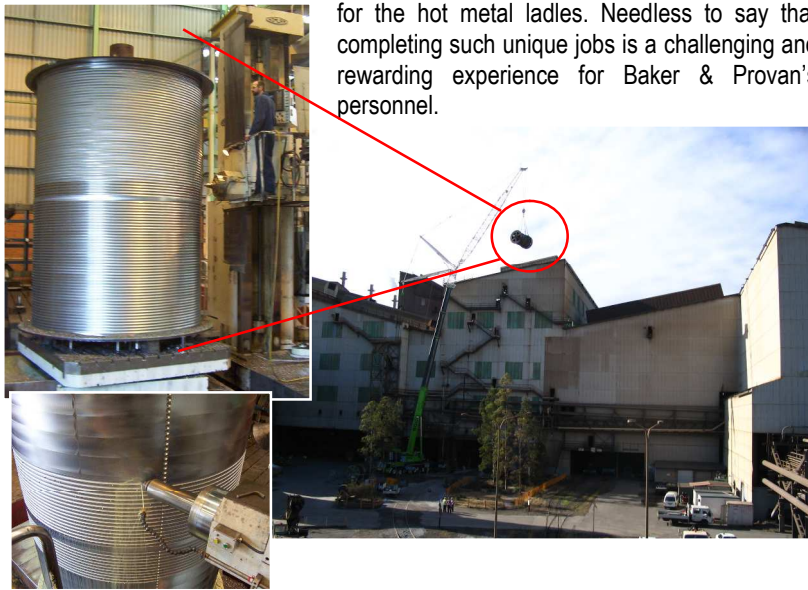
In early 2006, Baker & Provan manufactured (fabricated and machined) two heavy duty rope drums for Bluescope Steel. The Rope drums stand at 4 metres in length and diameter of 2.6 metres. The machining of the intricate left and right handed spiral rope grooves became a formality after proper planning of the job, with the services of a 6 axis modern CNC Floor Borer, with a rotary table rated to 30 tonne, and the all important highly skilled operators.

After delivery to Bluescope Steel, the rope drum was installed at Bluescope Steel's Port Kembla steel works in the Basic Oxygen Steel Making Plant to form part of a 470 tonne over head travelling crane for the hot metal ladles. Needless to say that completing such unique jobs is a challenging and rewarding experience for Baker & Provan's personnel.

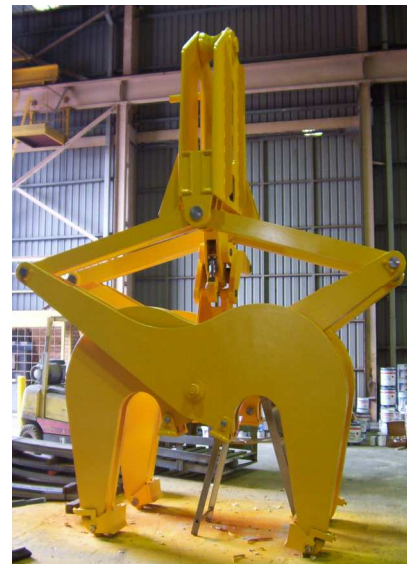
This large tong was fabricated, machined and assembled by Baker & Provan for Bluescope Steel. This tong was made from a special order of 75mm Bisalloy 80 plate. The tong stands at approximately 5 metres high and weighs around 14 tonnes. The handling of the assembly was quite tricky when aligning the large moving parts. The sequential assembly and handling of the heavy tongs was a challenging task, noting the freedom of movement of the heavy parts.

The tongs were an upgrade for the Hot Strip Mill within Bluescope Steel's Port Kembla steel works used to lift back up rolls weighing 75 tonnes.

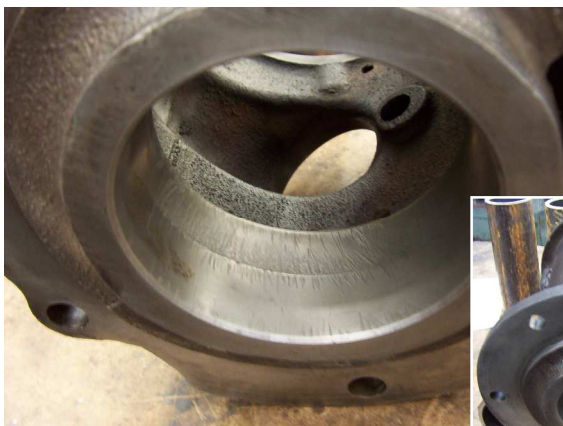
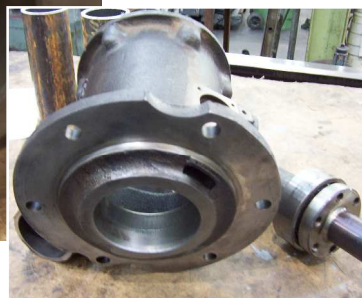
repaired by locking in an insert and machining the diameter back to original specification. This solution provides a robust repair procedure which is guaranteed not to fail, within the design loads of the component.

While metal spray repair is a valuable repair procedure, it also has its limitations. The high speed bearing housing below is an example of a bearing face that was metal sprayed. The shaft bearing surface picked up on the housing and caused a repeat failure. Metal spray repair can be a poor solution when the bore diameter is large, when there is vibration or in high speed applications. Such conditions are likely to cause failure of the metal sprayed surface within 12 months of usage.

Baker & Provan has developed a repair procedure which permits failed bearing surfaces (and other surfaces) to be

Furthermore, the insert provides a secondary benefit. If the loads on the component cause wear over time, then it becomes a straight forward repair to replace the insert providing a quick turnaround and further savings on repair costs.
